**INVESTIGATION OF THE CAUSES OF SILICON MOS —
TRANSISTOR PARAMETERS CATASTROPHIC DEGRADATION**

O. Kulinich, M. Glauberman, G. Chemeresuk, I. Yatsunsky

Mechnikov National University of Odessa
(Training, Scientific-Investigation and Production Center, Physical faculty),
4 Marshala Govorova st., Odessa 65063, Ukraine,
tel.: +380482 607252, fax: +380482 544491, e-mail: eltech@elaninet.com

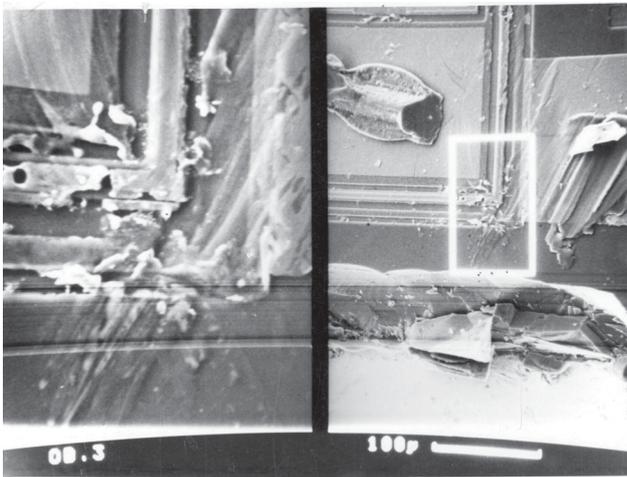
Figs. 1 (a,b) show the pictures of the disclosed latent defects, breaking of integrity of the metallized path to the gate, and mechanical damage of the pad for thermal compression, which come out after ionic etching for 25 minutes. Survey of this area in the reverse-biased electrons and absorbed current mode has shown that there are sections of lower conduction and break area. A micro-X-Ray spectrum analysis of the current conducting path has revealed the presence of both aluminum and molybdenum, and Al_xSi_2 and Mo_xSi_2 silicides in it. Intermetallic compounds of Al_xAu_y and $\text{Al}_x\text{Au}_y\text{Mo}_z$ types have been found in the area of thermal compression contacts (Figs. 2).

Fig. 1,a Image of the metallization integrity breaking defect.

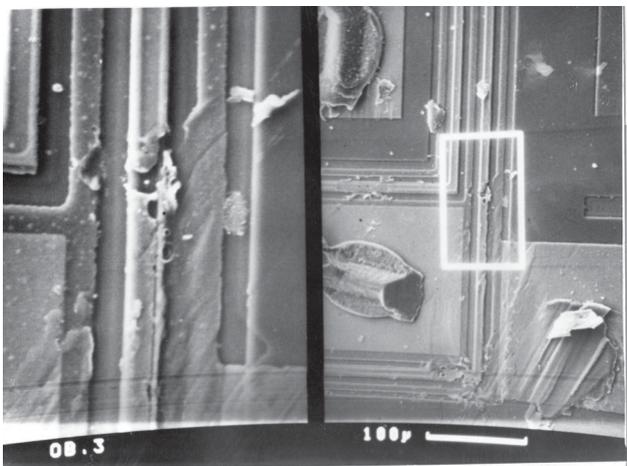
Fig. 1,b. Image of the metallization integrity breaking defect (photolayer etching).

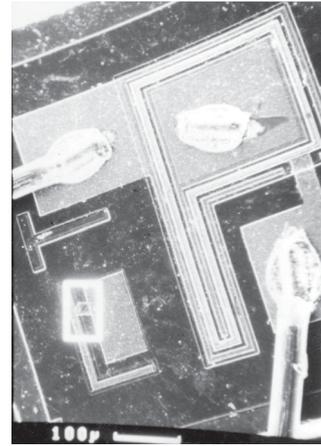
Fig. 2. Image of the thermal compression contact break picture (general view).

The revealed intermetallic compounds led to brittleness and, as a consequence, to ruptures of the thermal compression gold-aluminum contacts.

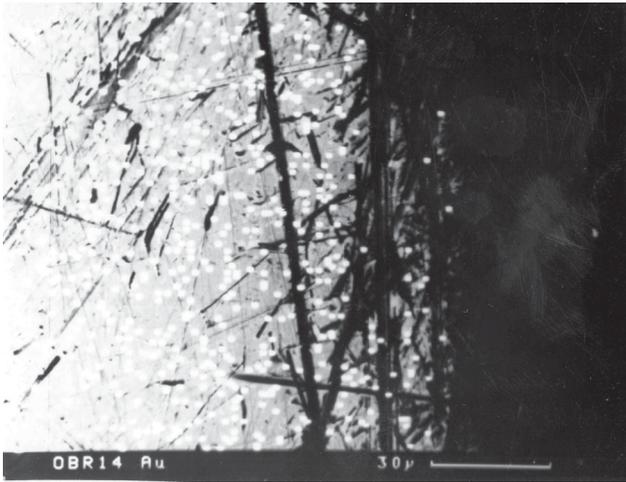
These compounds have a complex composition, depending on the conditions of their formation (gold and aluminum concentrations, temperature and pressure in the thermal compression process, free silicon presence, ambient temperature and service time of the ready MOS-transistor). Due to the difference in the lattice constants, formation of these compounds gives rise to mechanical stresses at the interface. It is well known that the yield point of crystalline substances depends on temperature [5]. The contacts are heated by the current flow, and as a consequence, in destruction of the contact. A detailed analysis of the failure mechanism has made it possible to find out, that interaction and interdiffusion of gold and aluminum occur in the process of thermal compression welding at the temperature of about 300°C , the diffusion rate of gold into aluminum being higher due to the higher value of gold diffusivity (Fig. 3). This diffusion causes formation at the Au-Al interface of intermetallic compounds, whose lattice constants parameters and thermal expansion coefficients differ from the similar lattice parameters of Au and Al, which gives rise to mechanical stresses. Metallization discontinuities have been found to be localized in areas of maximum dislocation clusters (Figs. 4) or lamellar nonuniformity defects clusters (Figs. 5), when the metallization is pickled off and the silicon

Fig. 3. Electronic image of the gold to aluminum diffusion process.

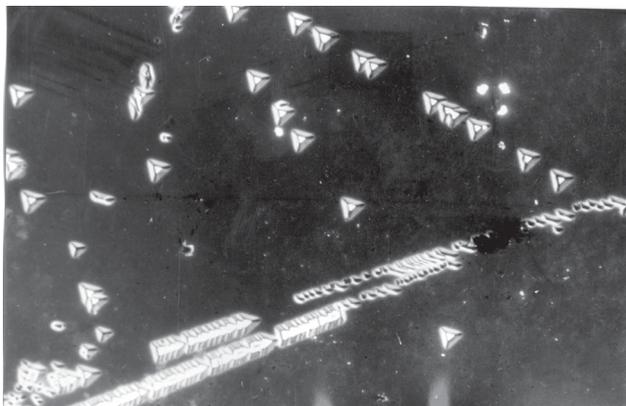
Fig. 4. Electronic image of the dislocation cluster areas, revealed on the silicon surface after removal of the faulty metallization and treatment with the Secco selective etchant.

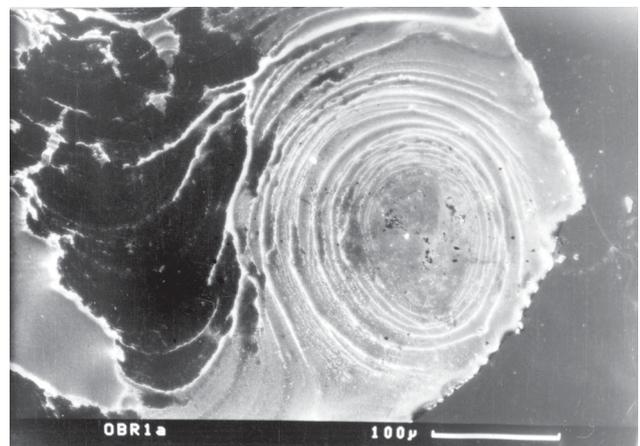
surface is treated with Secco (100) or Sirtl (111) [3,4] selective etchant. Despite the good metal-to-silicon adhesion, mechanical stresses arose in these areas, which caused destruction of the metal. Some cases of breaking the metallization uniformity could be associated with metal etching under a photoresist. The experiments have shown the metallization breaking to be largely dependent on the device formation technology.

Fig. 5. Electronic image of the lamellar nonuniformity defect, revealed on the silicon surface after removal of the faulty metallization and treatment with the Secco selective etchant.
